Manhole Inspection Summary

Manhole # S39KK_021MH

Location Address: **1225 NORTH AVE**

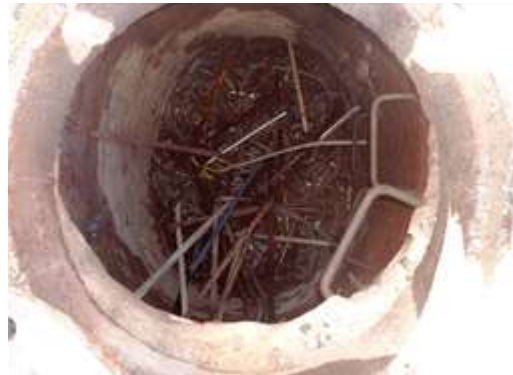
Top View

Barrel infiltration. Channel debris.

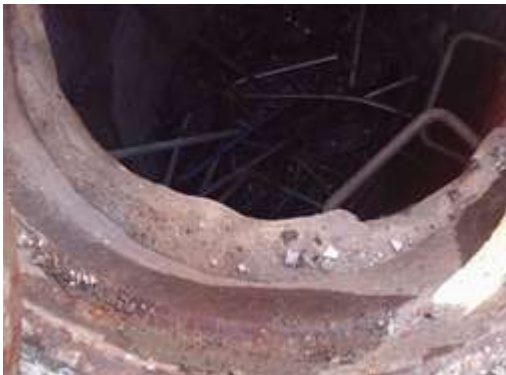
Defect

Frame leaks. Frame offset.

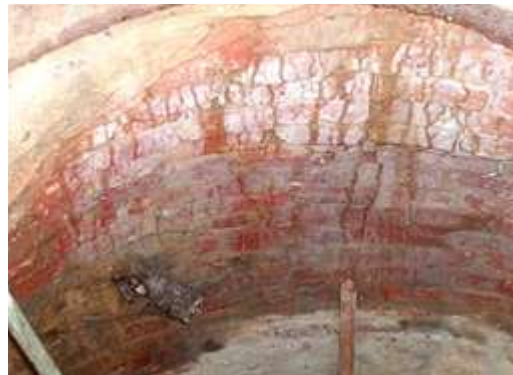
Defect

Frame leaks. Adjustment and Corbel infiltration.

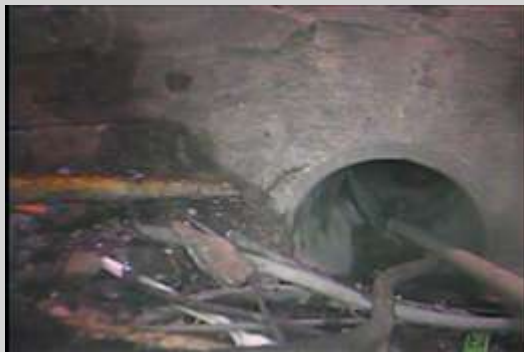
8 in. Circular Gravity Sewer
Pipe Out @ 12 O'Clock

Deposits: ☐ None ☐ Mud ☐ Sludge ☒ **Debris** ☐ Grease

Silt Depth: **0** (in.) Deposits Extent: **Light**
